DIGITAL TOOLS

ECOTEC

DESCRIPTION

The following project is a CASA-STUDIO located in a residual space between buildings. Solar analysis will be applied to this building in order to understand the light effect.

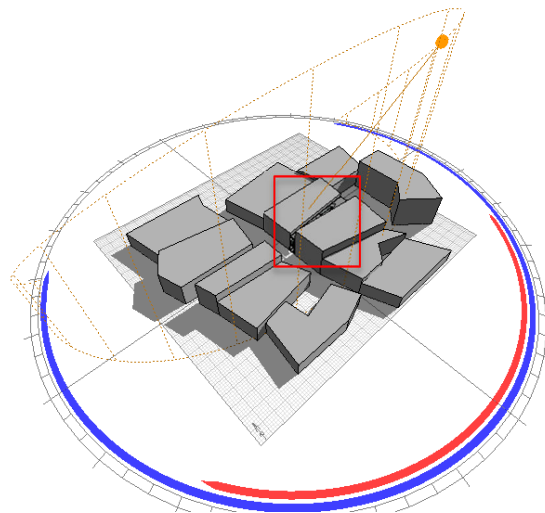
SHADOWS DURING MORNING: July 15th 10 00 HS

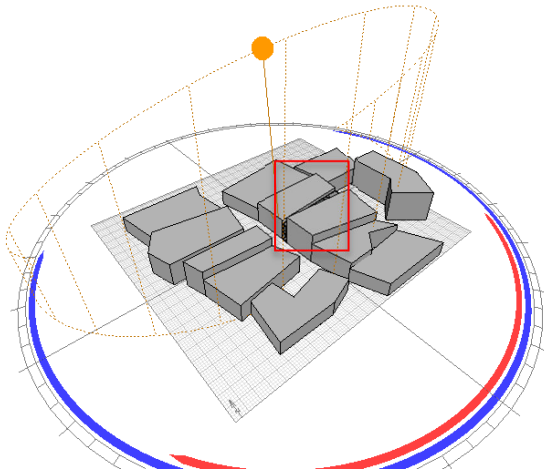
SHADOWS DURING NOON: July 15th 13 00 HS

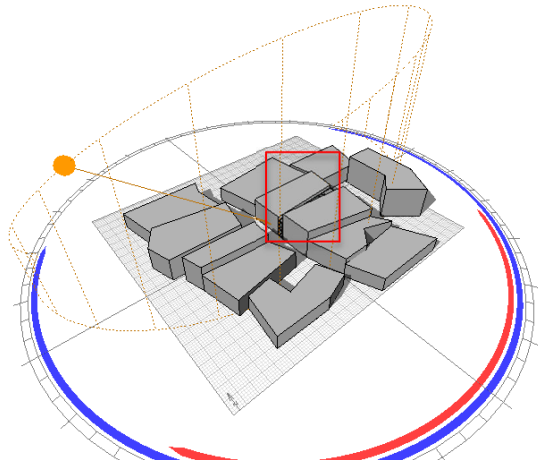
SHADOWS DURING NOON: July 15th 18 00 HS

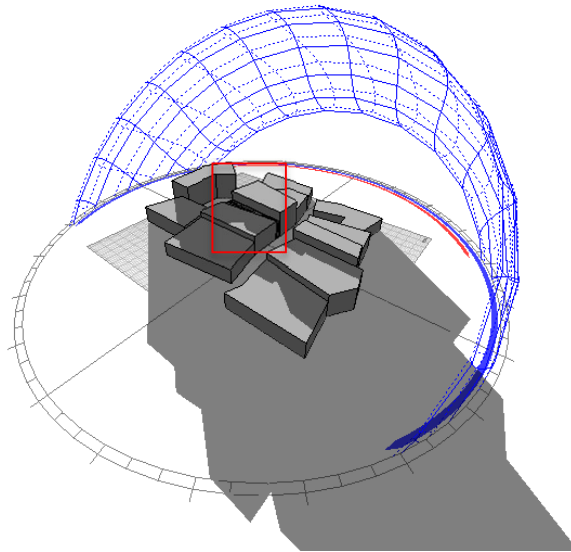
SHADOWS - JANUARY

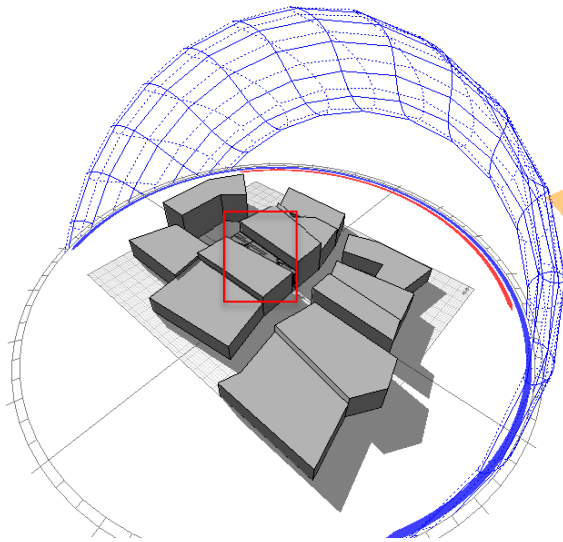
SHADOWS - MAY

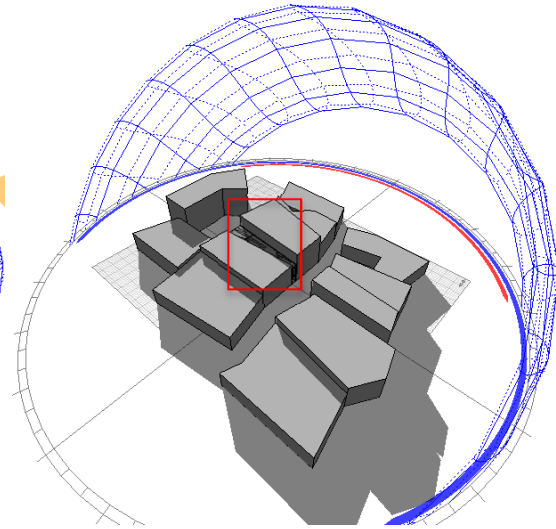
SHADOWS - OCTOBER

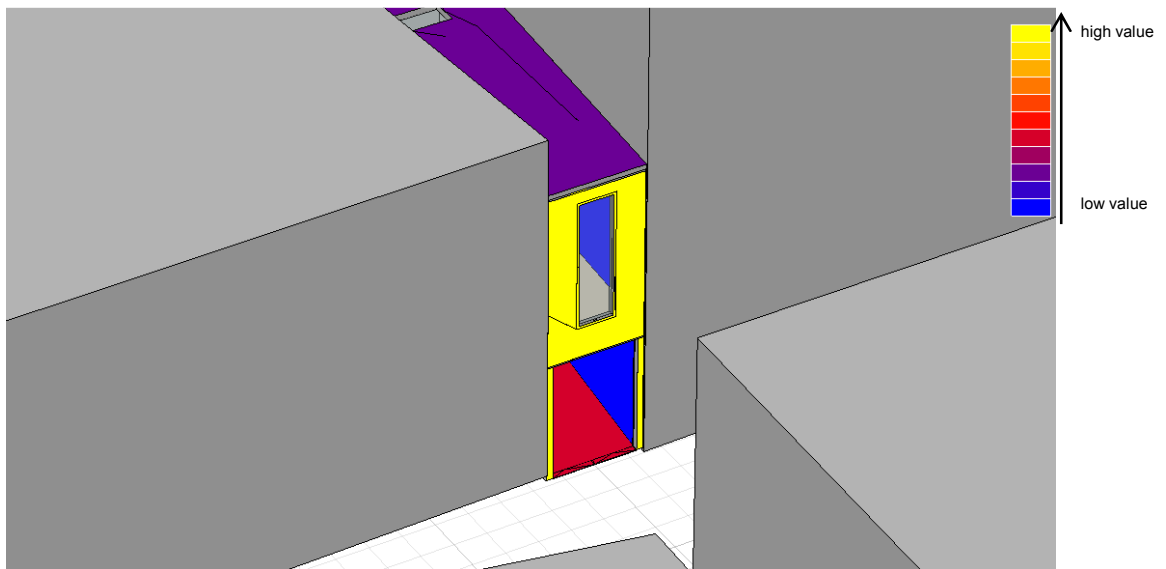
FRONT FACADE

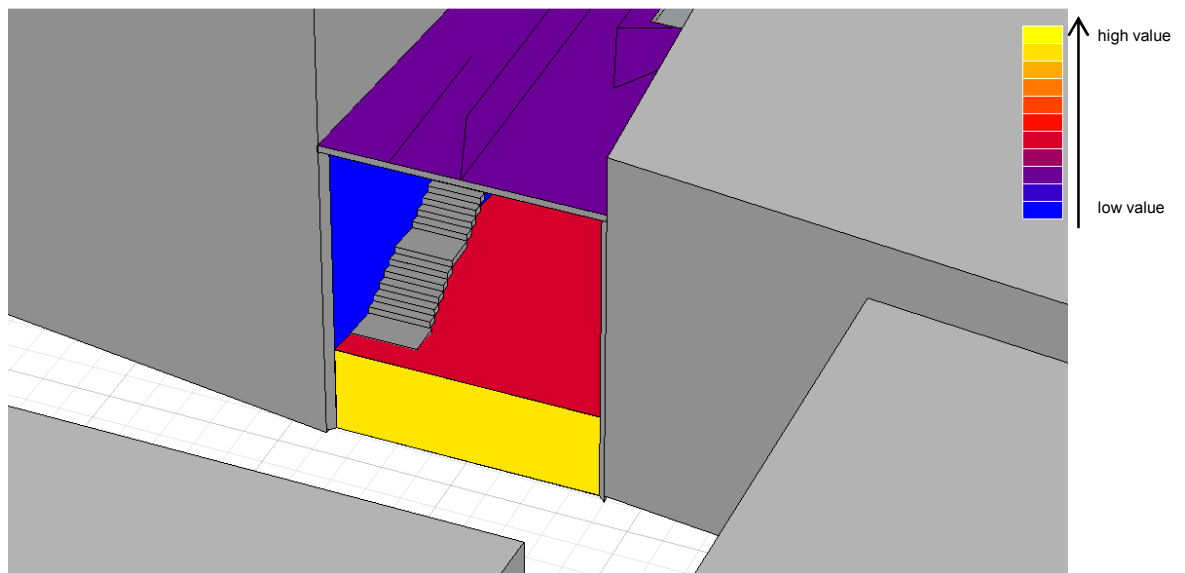
BACK FACADE

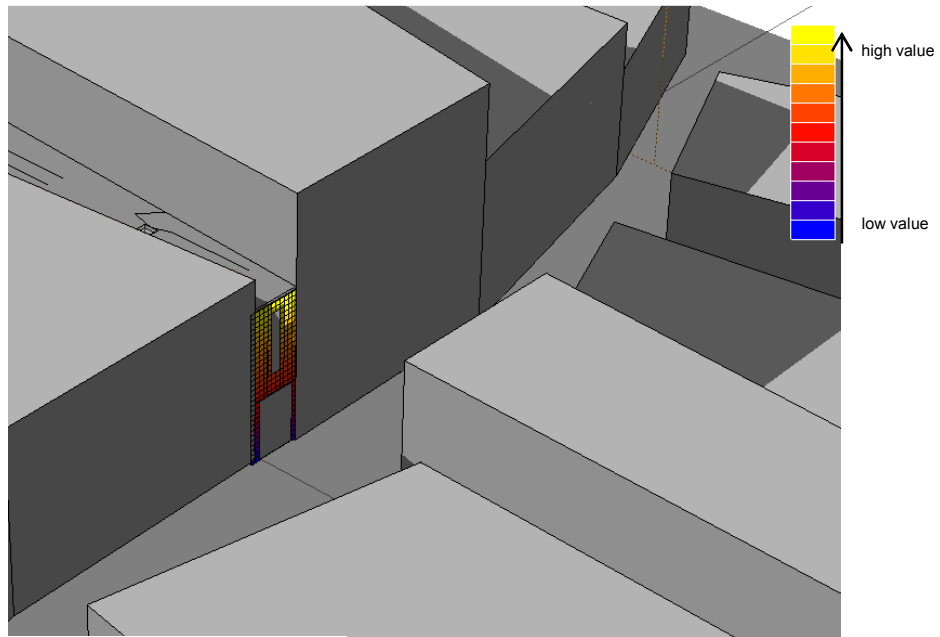
SHADOWS AT 7:00 HS

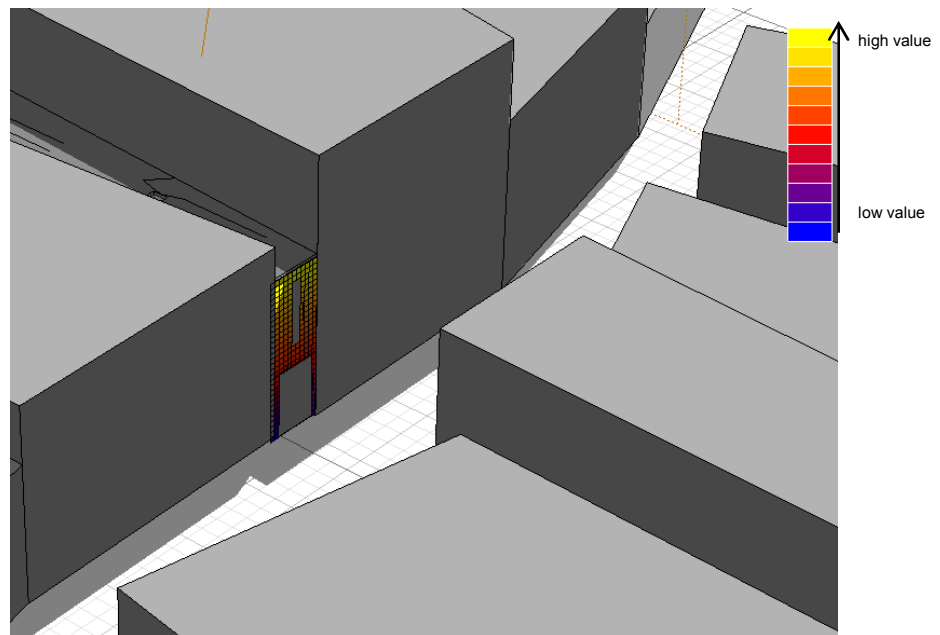
SHADOWS AT 12:15 HS

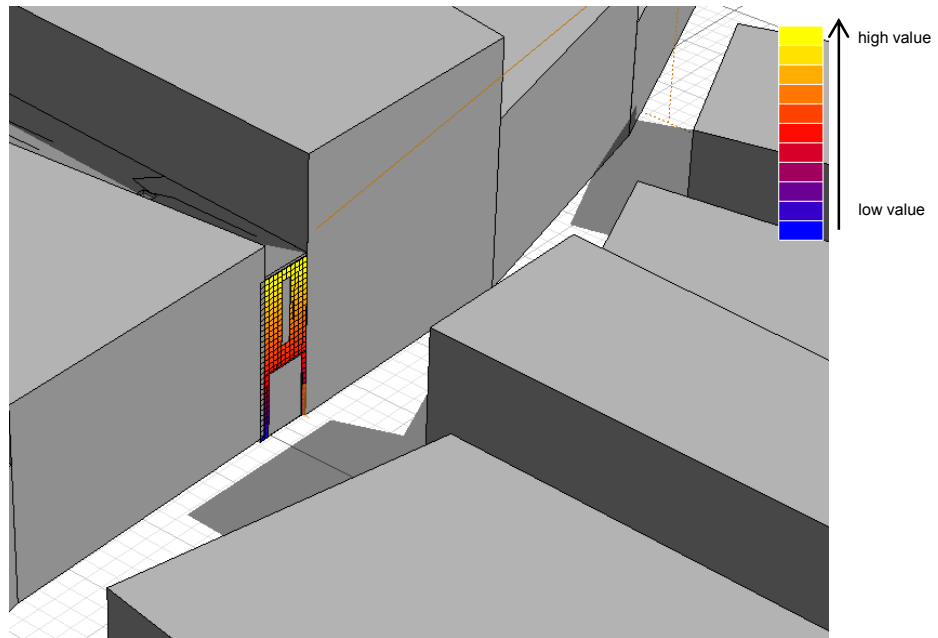
SHADOWS AT 15:30 HS

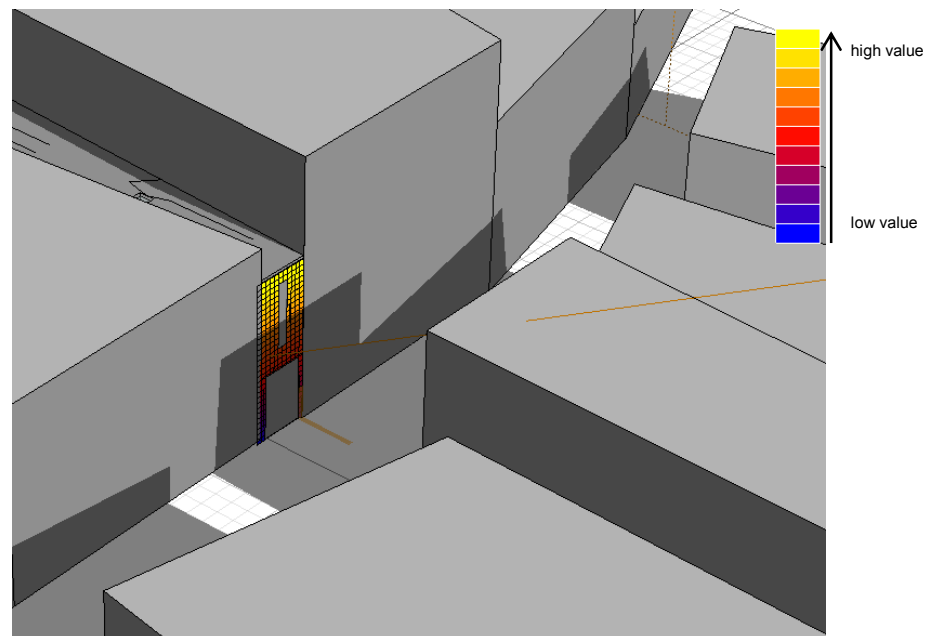
SHADOWS AT 17:15 HS

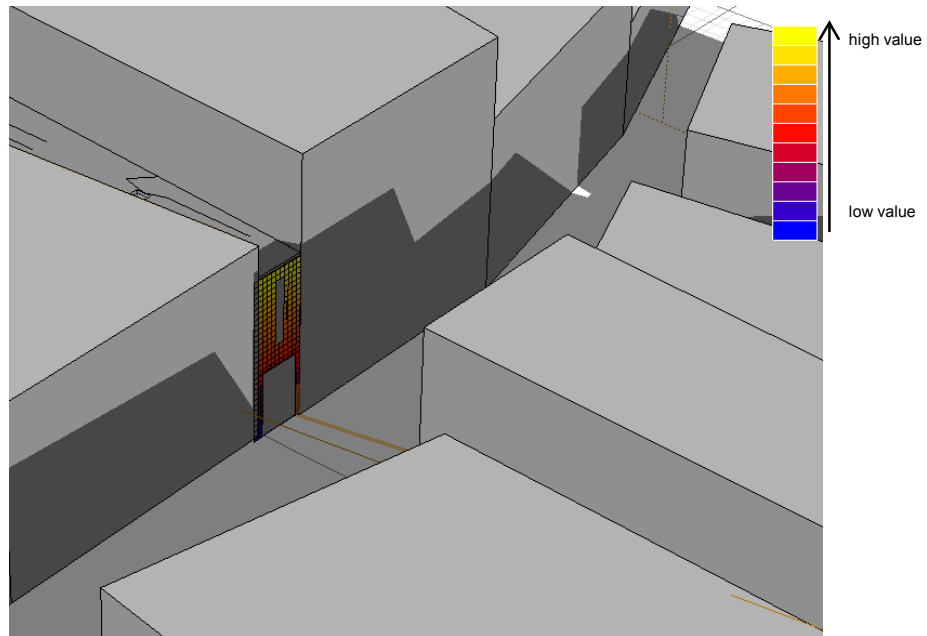
SHADOWS AT 18:15 HS

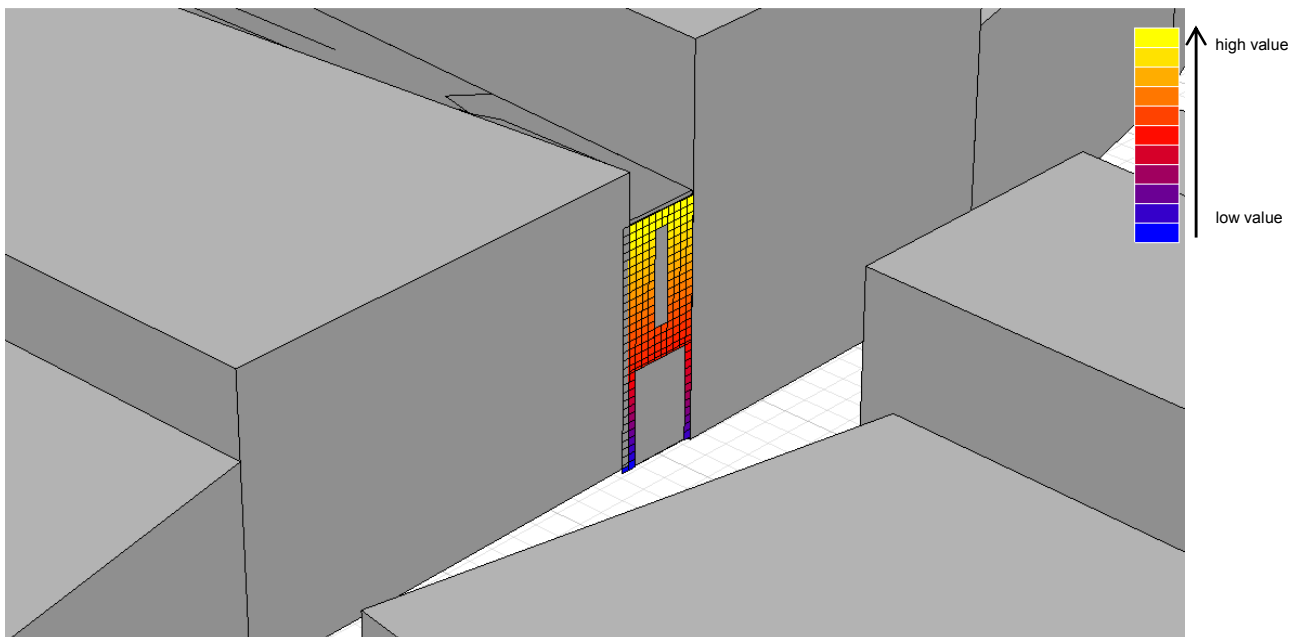
RESULTS OF THE LIGHT EXPOSURE OF THE FACADE

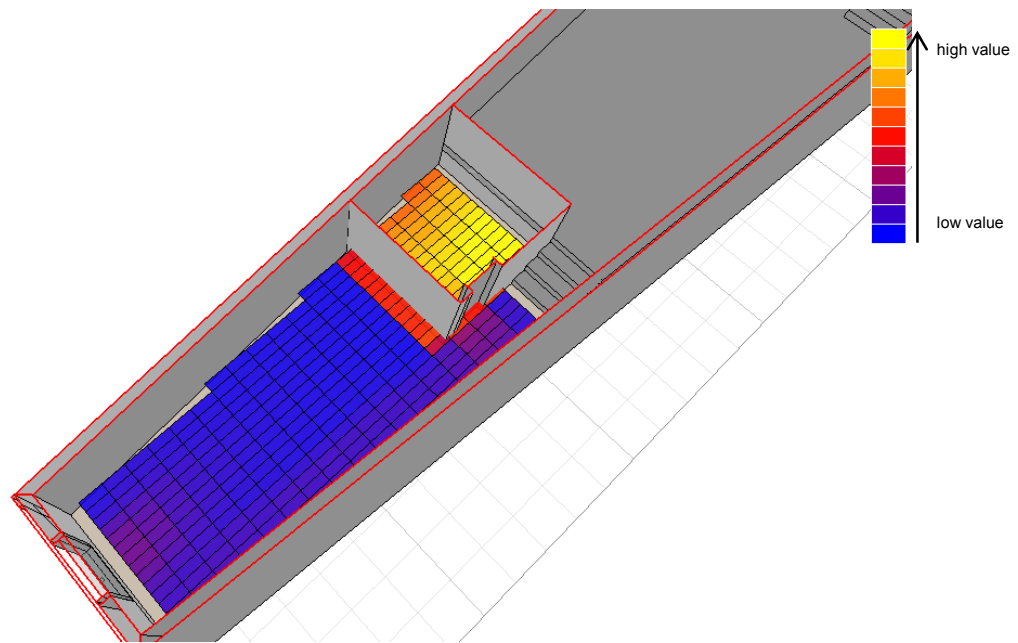
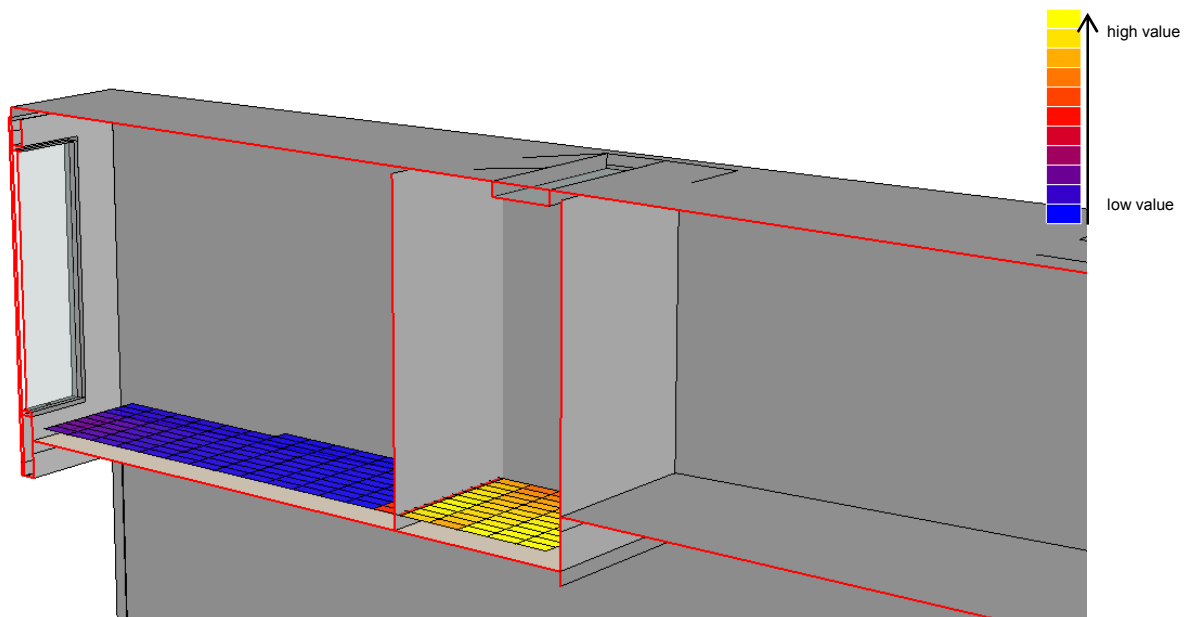
DAYLIGHT ANALYSIS

The light effect in the bathroom came from the skylight above.

Reflectance values: Internal divisions: 0.2. Walls: 0.5. Floor: 0.8. Ceiling: 0.7. Glass: 0.7

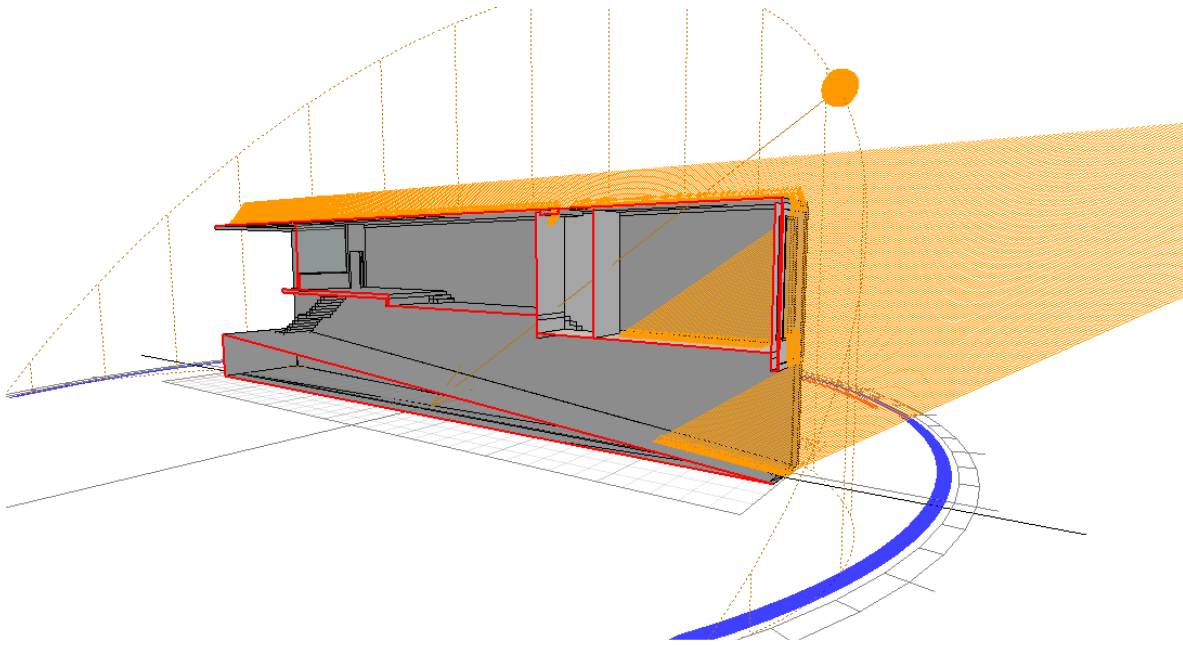
RAY LIGHT ANALYSIS

This exercise helps to understand the light ray's incidence in the front façade. The same procedure was developed for the back façade.

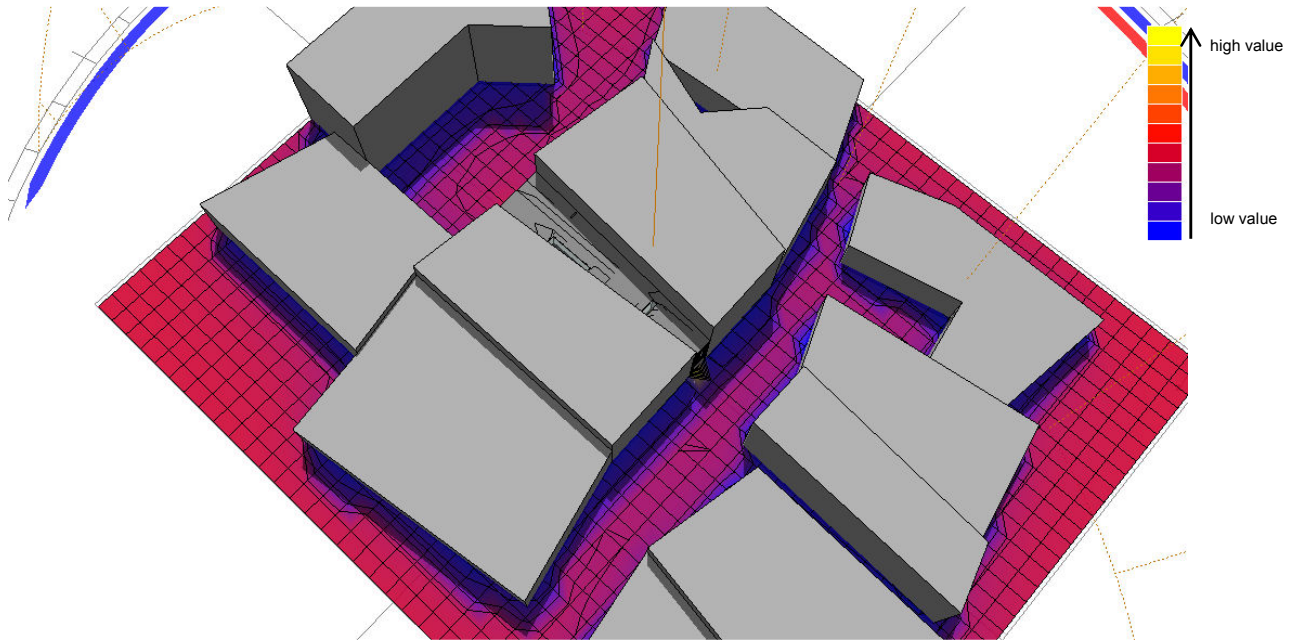
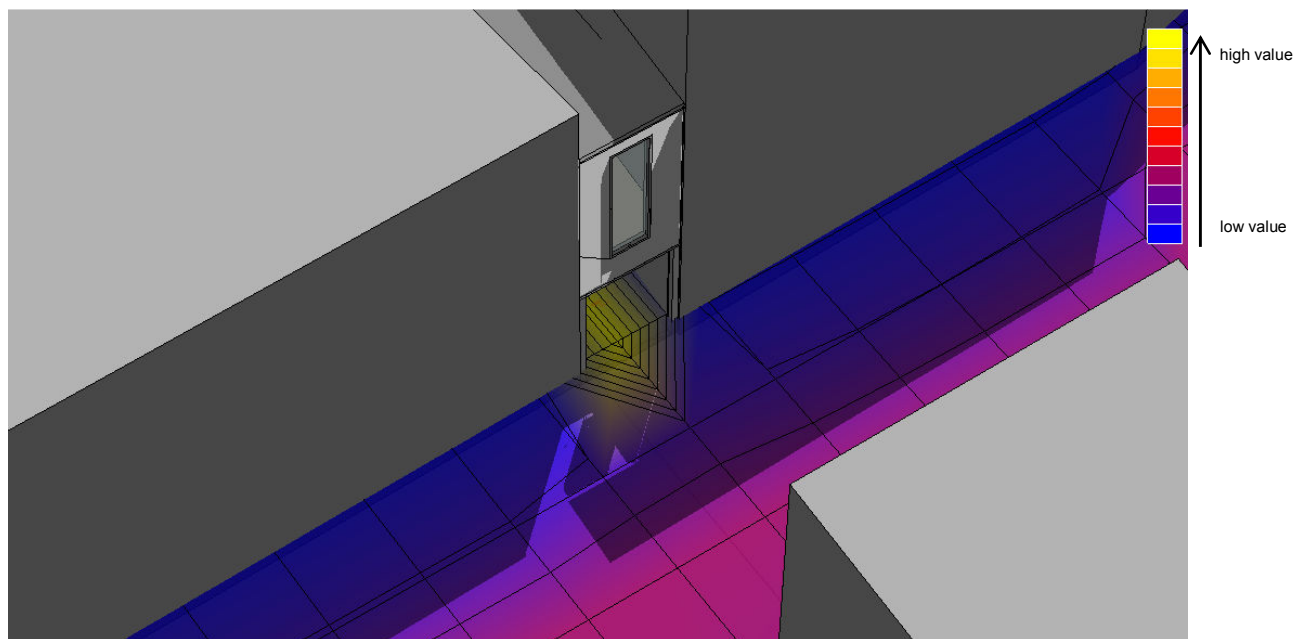
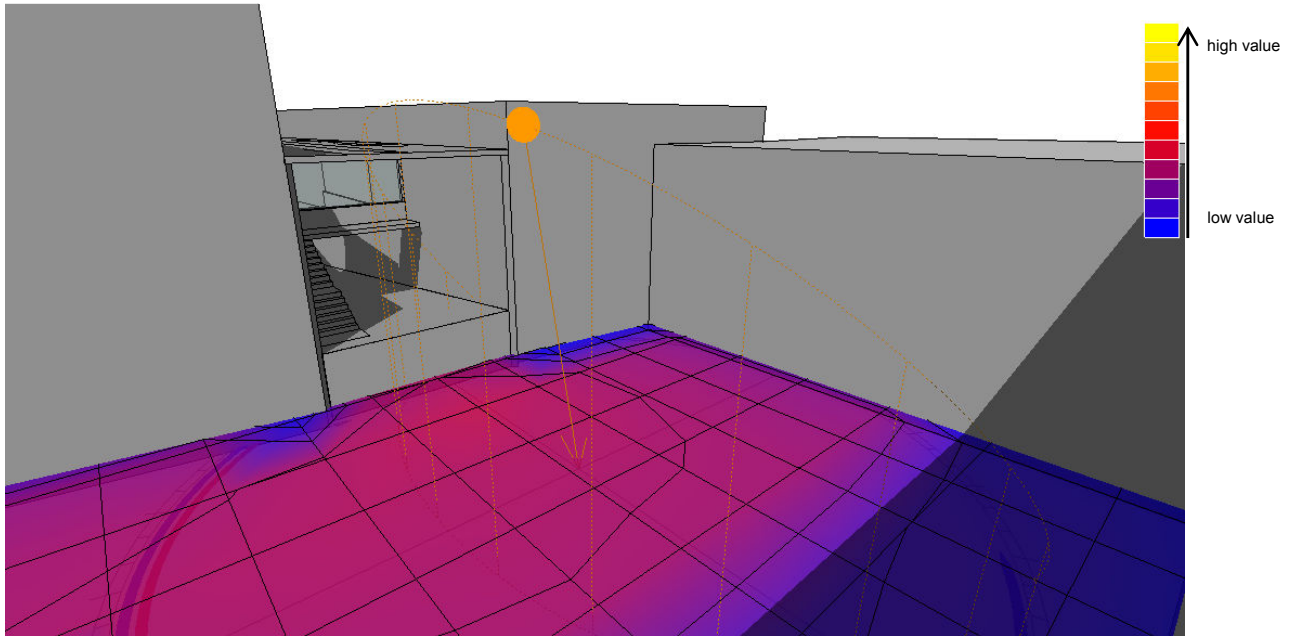
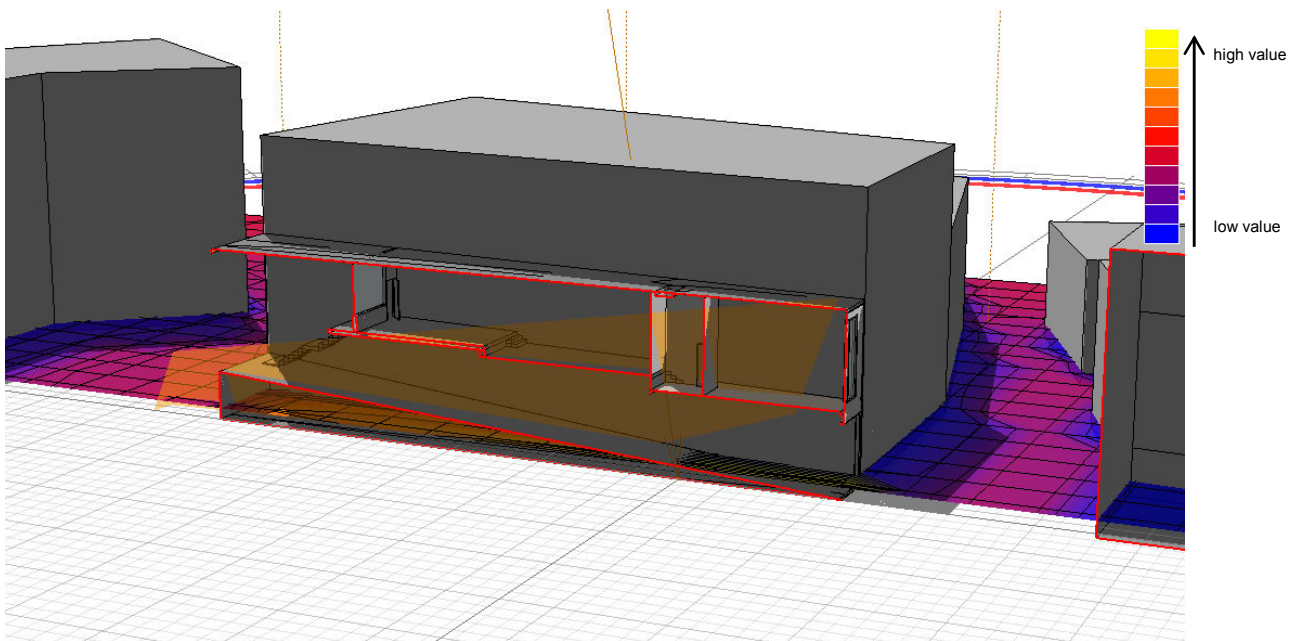
Radiant Temperature

THERMAL CONFORT ANALYSIS:
